## BRITISH RAILWAYS - Western Region

NOTICE TO TRAINMEN ETC.SIGNAL ALTERATIONSOLD OAK COMMONSATURDAY 8 OCTOBER TO MONDAY 10 OCTOBER 1977

In connection with the centralisation of signalling and remodelling of the track layout, the existing connections from the Engine and Carriage Line and the Up Goods Line to the Up Reception Lines and the South Siding Feeder Line will be taken out of use.

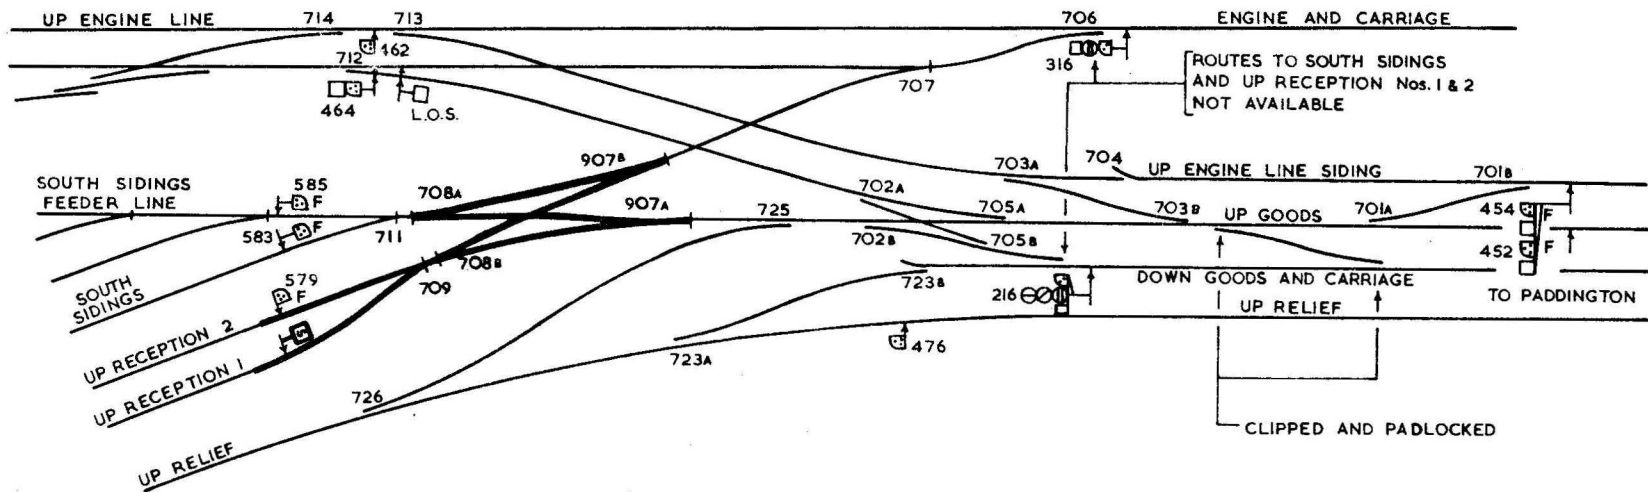
OLD OAK COMMON

At the same time the existing connection from the South Siding Feeder Line to the South Siding No.8 will be disconnected from the Panel signalbox. It will retain the number 711 for reference only.

A new connection from the Up Reception No.1 to the Up Reception No.2 Line will be laid in and allocated number 709 for reference only.

Signal 245 routed from the Up Reception No.1 Line to the Engine and Carriage Line or the Up Engine Line or the Up Goods, will be taken out of use.
